# Summary Action Report

Structure Name: North Perth Road 154 - Bridge between Line 81 and Lin  
 Structure No: E-9  
 MTO Site No: E-9

Inspection Date: 11/20/2013 mm/dd/yyyy Condition Index Value (BCI) 28.01  
 Next Biennial Inspection: 11/20/2015 mm/dd/yyyy

# Municipal Structure Inspection Form

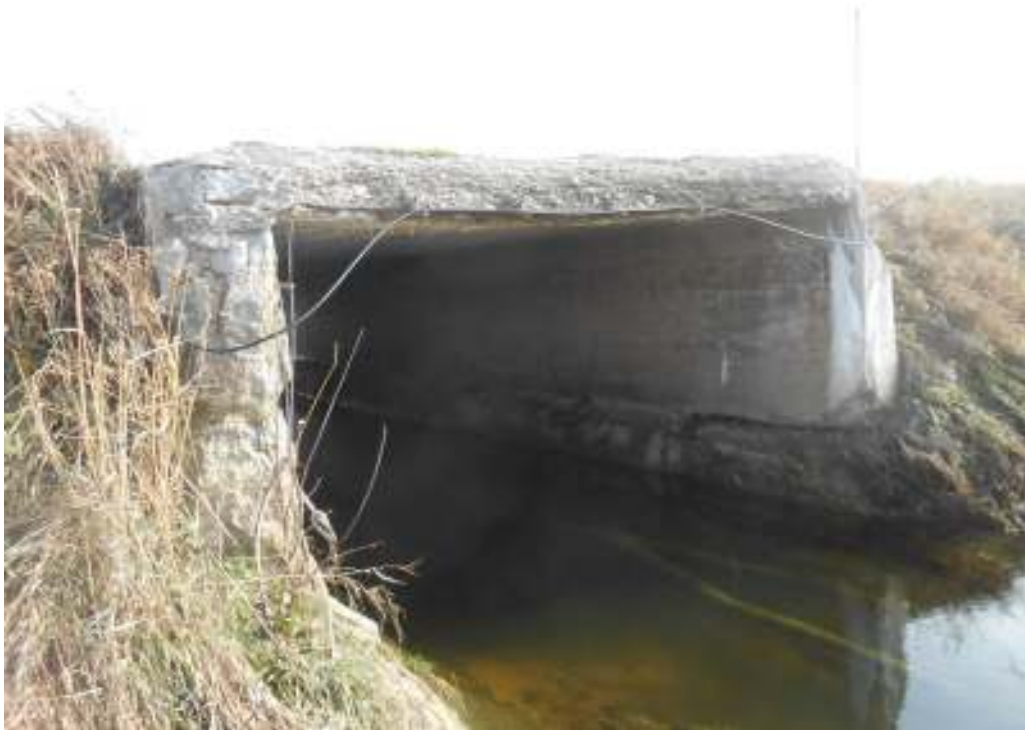
Photo 2: West face

Severe delamination and spalling; Severe disintegration with loss of section; Exposed corroded rebar; Wide cracks with efflorescence.

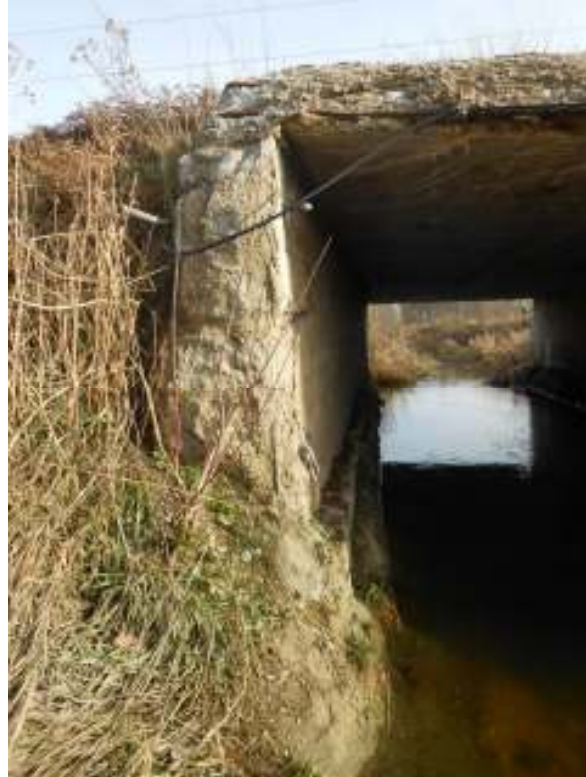
Photo 3: Northwest leg

Severe erosion and loss of section with wide cracks and severe delamination along top of footings throughout; Severe scaling and disintegration with severe delamination and spalling at ends; Wide vertical stained cracks; Rodent hole burrowed under legs.

Perform Deficiencies	Maintenance Needs	Priority	Maintenance Comments
Load carrying capacity	None	None	
Rehab/Repair Recommendations	Priority	Total Cost	Comments
	1-5 yrs	275,000.00	Replace culvert

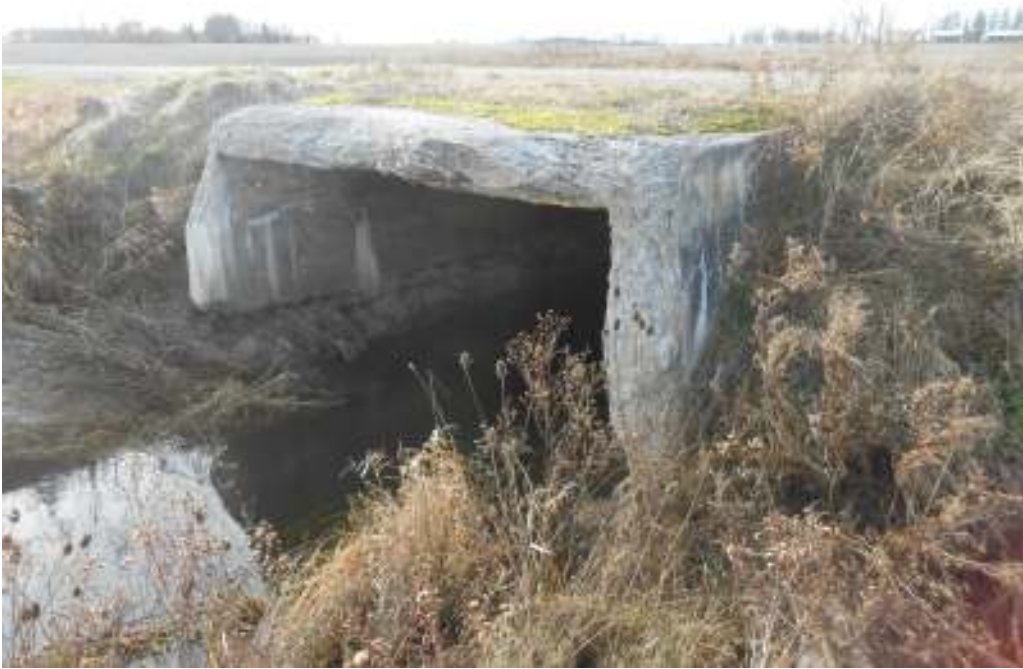
Photo 5: East face

Severe delamination and spalling; Severe disintegration with loss of section; Exposed corroded rebar; Wide cracks with efflorescence.

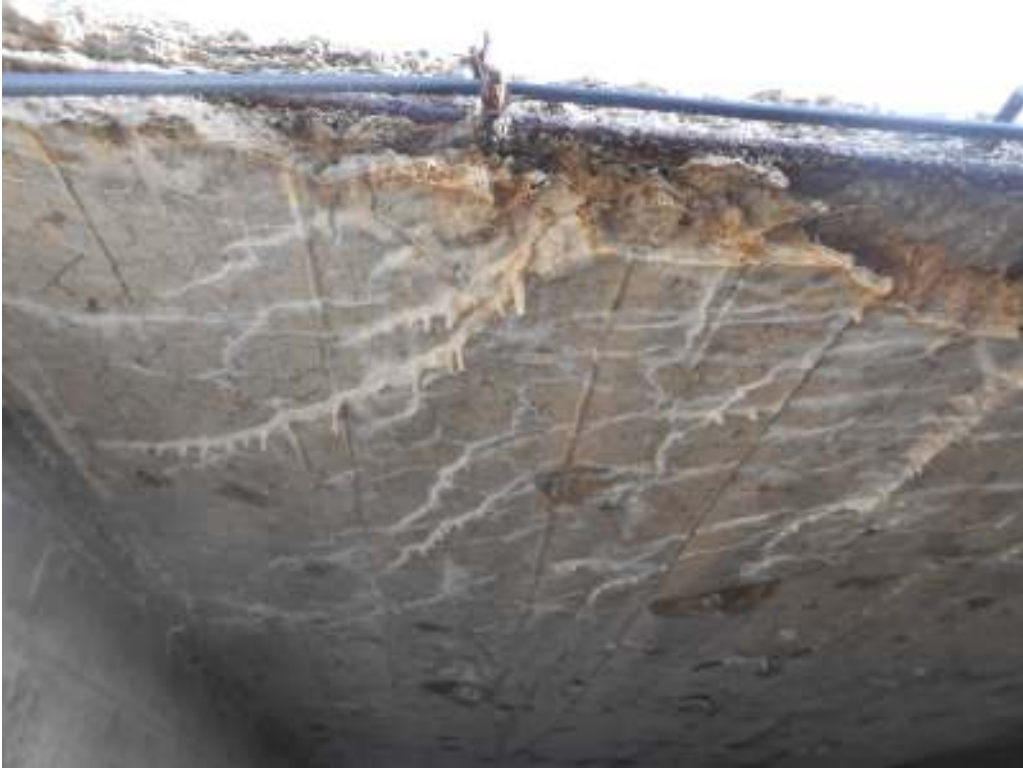
Photo 11: Soffit, west end

Severe disintegration with wide cracks, efflorescence, severe delamination and spalling and exposed corroded rebar at each end; Light to medium scaling; Medium to wide wet pattern cracking with efflorescence; Random severe popouts and spalls.

Perform Deficiencies	Maintenance Needs	Priority	Maintenance Comments
None	None	None	
Rehab/Repair Recommendations	Priority	Total Cost	Comments
	1-5 yrs	275,000.00	Replace culvert
